# Second International Conference on Case Histories in Geotechnical Engineering

June 1-5, 1988

## Vol. II

Editor: Shamsheer Prakash

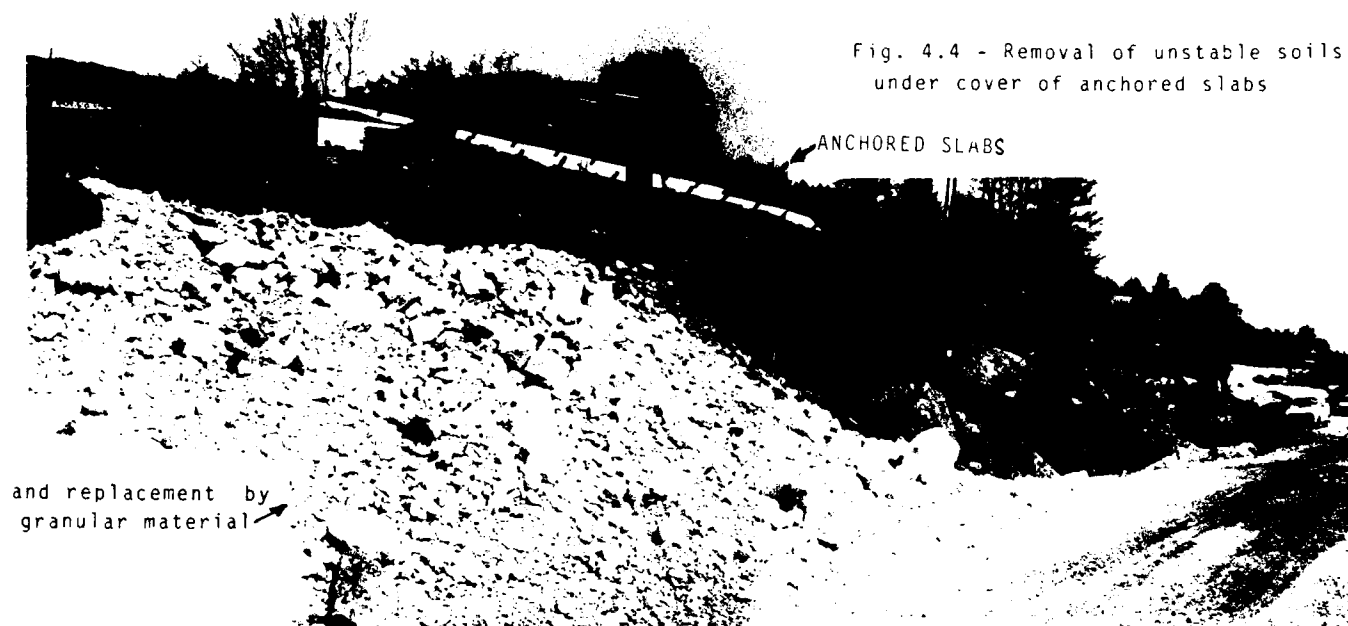
Fig. 4.4 - Removal of unstable soils under cover of anchored slabs
